MOLD INSPECTION AND TESTING REPORT

CLIENT	Linda Ayres
PROPERTY ADDRESS	58137 Sun Mesa Dr ~ Yucca Valley, CA 92284
DATE OF INSPECTION	Tuesday, June 23, 2020

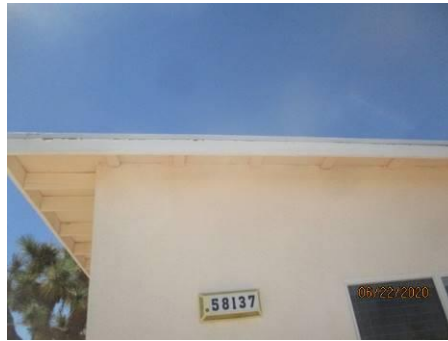
EXTERIOR [South Side]

The structure does not have rain gutters.

No rain gutters observed. Client stated that the roof had been blown off, and the home endured 40 days of unmitigated moisture intrusion.

Suspected source(s) of water intrusion: **Lack of rain gutters and previous lack of roof for 40 days**

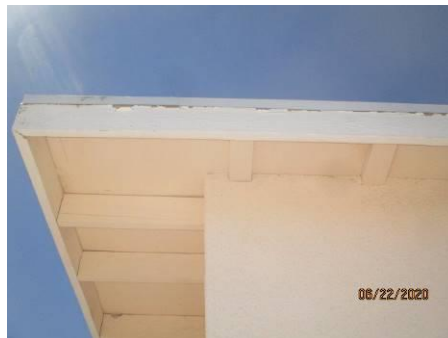
EXTERIOR [South Side]

Staining, discoloration, and/or visible signs of water damage were observed.

Water damage observed on eaves of roof.

Suspected source(s) of water intrusion: **Previous roof leak and previous lack of roof for 40 days**

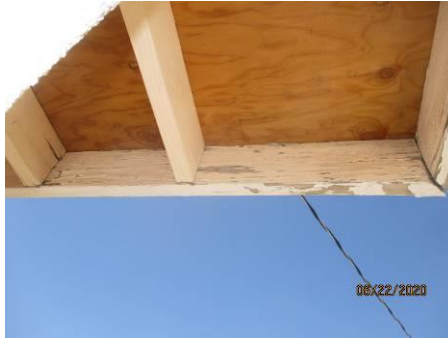
EXTERIOR [South Side]

Staining, discoloration, and/or visible signs of water damage were observed.

Water damage observed on eaves of roof.

Suspected source(s) of water intrusion: **Previous roof leak and previous lack of roof for 40 days**

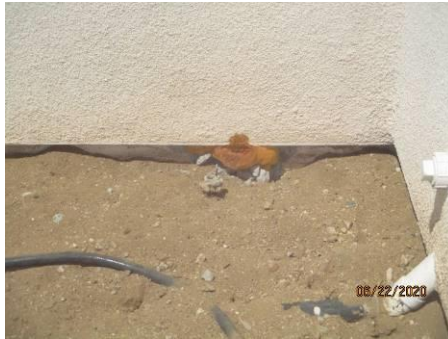
EXTERIOR [West Side]

Foundation crack(s).

Cracked foundation observed.

Area affected: **~2 Linear Ft**

Suspected source(s) of water intrusion: **Cracked foundation**

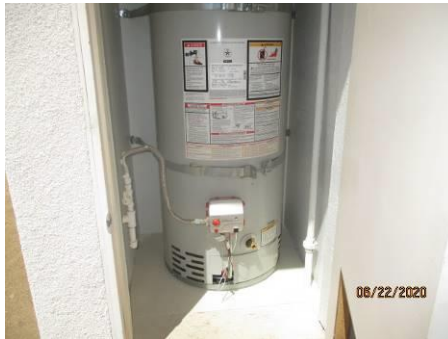
WATER HEATER CLOSET [West Side]

Client stated previous water intrusion affected this area.

Client stated previous roof leak affected this area.

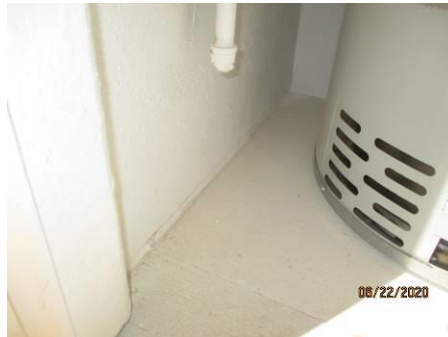
WATER HEATER CLOSET [West Side]

Staining, discoloration, and/or visible signs of water damage were observed.

Water staining and discoloration observed around water heater unit.

Area affected: **~2 Linear Ft**

Suspected source(s) of water intrusion: **Previous roof leak and previous lack of roof for 40 days**

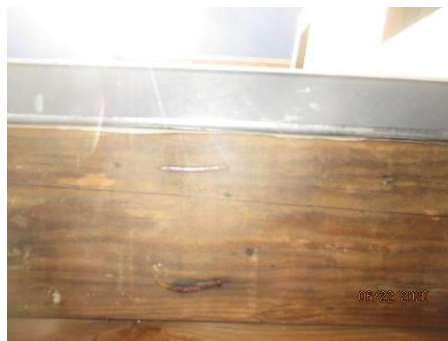
WATER HEATER CLOSET (FRAME) [West Side]

Lab Code	Location	Conclusion	Comments
DE1	Water Heater Closet (Frame)	Mold Growth: Brown hyphae with no associated spores, ID unknown; and Stachybotrys species	Recommended by inspector and approved by client
DE2	Bathroom (Sheathing)	Mold Growth: Brown hyphae with no associated spores, ID unknown; and Ulocladium species	Recommended by inspector and approved by client

Suspect mold-like growth was observed.

Mold-like growth observed on water heater closet stud.

Area affected: **~2 Linear Ft**

Suspected source(s) of water intrusion: **Previous roof leak and previous lack of roof for 40 days**

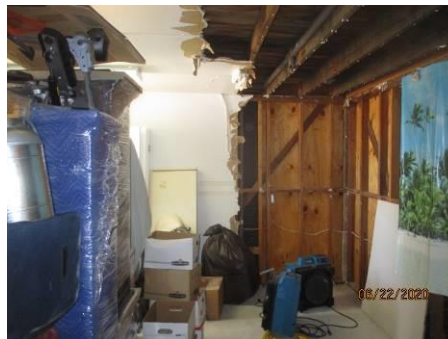
GARAGE [South Side]

Staining, discoloration, and/or visible signs of water damage were observed.

Water staining and discoloration observed on studs, sheathing and joists.

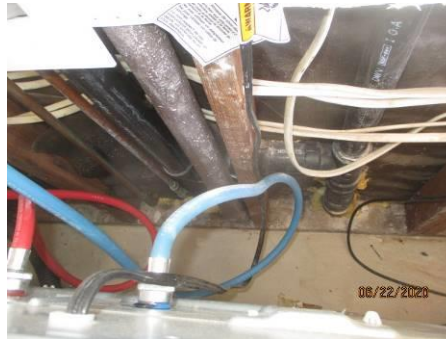
GARAGE [North Side]

Staining, discoloration, and/or visible signs of water damage were observed.

Water staining and discoloration observed on studs and sheathing behind laundry machines.

Area affected: **~4 x 3 Ft**

Suspected source(s) of water intrusion: **Previous frozen pipe leak**

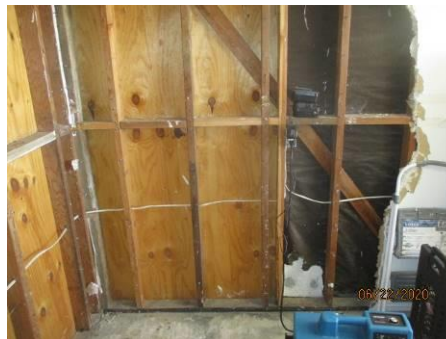
GARAGE [North Side]

Staining, discoloration, and/or visible signs of water damage were observed.

Water staining and discoloration observed on studs, sheathing and joists.

Area affected: **~8 x 4 Ft**

Suspected source(s) of water intrusion: **Previous frozen pipe leak**

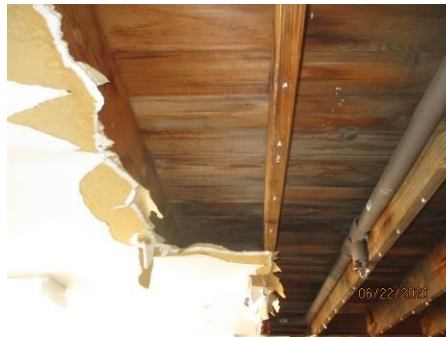
GARAGE [Ceiling Corner]

Staining, discoloration, and/or visible signs of water damage were observed.

Water staining and discoloration observed on studs, sheathing and joists.

Area affected: **~12 x 5 Ft**

Suspected source(s) of water intrusion: **Previous frozen pipe leak**

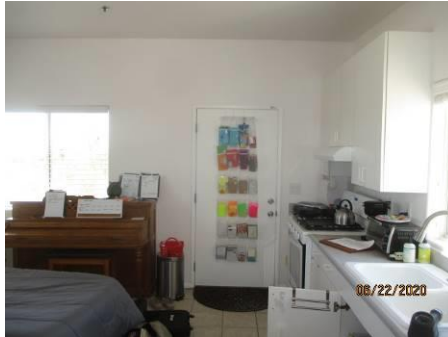
KITCHEN [East Side]

Staining, discoloration, and/or visible signs of water damage were observed.

Water staining and discoloration observed under sink cabinetry.

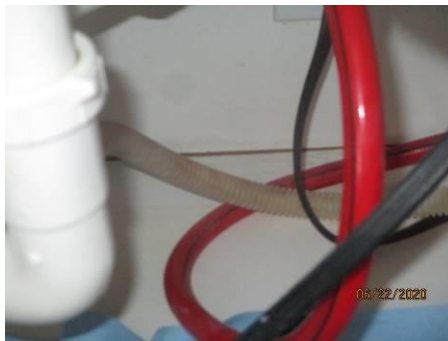
KITCHEN [South Side]

Staining, discoloration, and/or visible signs of water damage were observed.

Water staining and discoloration observed under sink cabinetry.

Area affected: **~2 Linear Ft**

Suspected source(s) of water intrusion: **Previous sink plumbing leak**

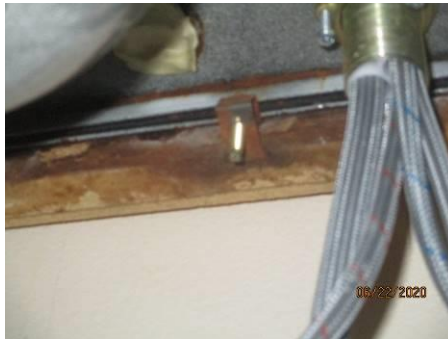
KITCHEN [South Side]

Staining, discoloration, and/or visible signs of water damage were observed.

Water staining and discoloration observed under sink cabinetry.

Area affected: **~2 Linear Ft**

Suspected source(s) of water intrusion: **Previous sink plumbing leak and/or incidental water from sink**

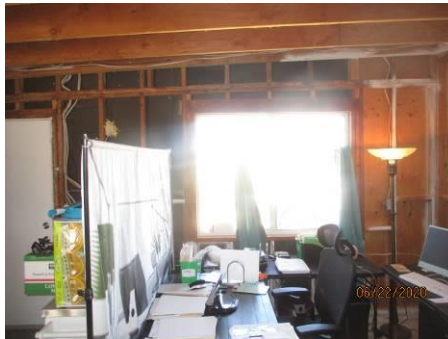
LIVING ROOM [North Side]

Client stated previous water intrusion affected this area.

Client stated roof previously blown off and was unmitigated for 40 days.

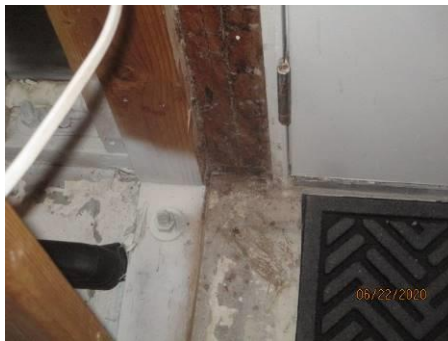
LIVING ROOM [North Side]

Staining, discoloration, and/or visible signs of water damage were observed.

Water staining and discoloration observed on studs.

Area affected: **~2 Linear Ft**

Suspected source(s) of water intrusion: **Previous lack of roof for 40 days**

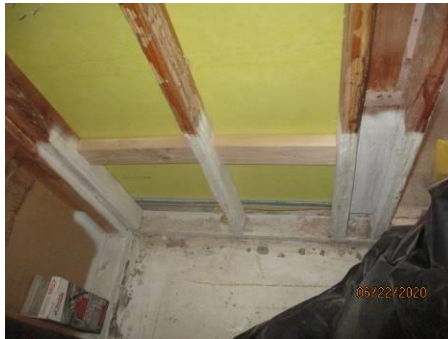
LIVING ROOM [South Side]

Debris was observed.

Debris observed on encapsulation.

Area affected: **~3 Linear Ft**

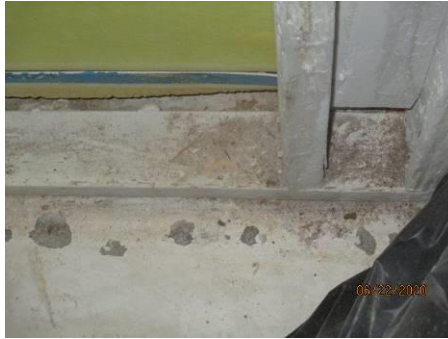
LIVING ROOM [South Side]

Debris was observed.

Debris observed on encapsulation.

Area affected: **~3 Linear Ft**

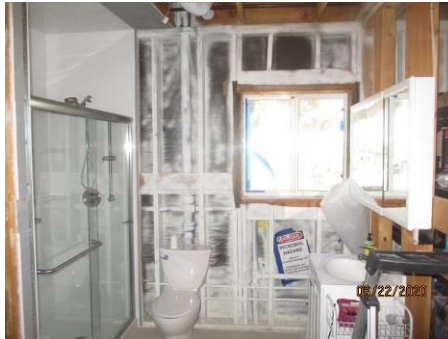
BATHROOM [South Side]

Client stated previous water intrusion affected this area.

Client stated previous roof leak affected this area.

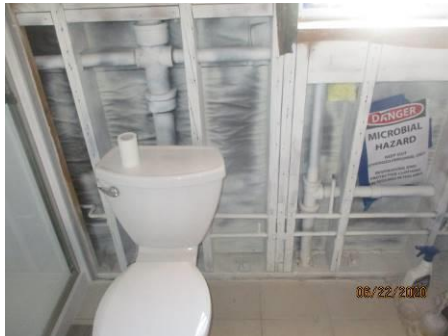
BATHROOM [South Side]

Encapsulation was observed.

Encapsulation observed on building materials.

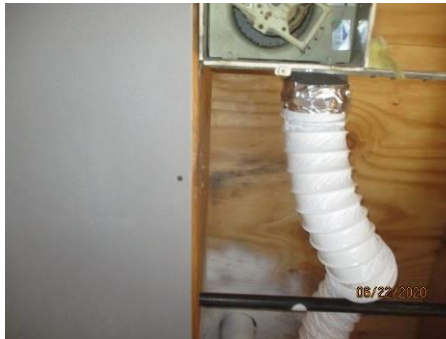
BATHROOM [Ceiling Corner]

Staining, discoloration, and/or visible signs of water damage were observed.

Water staining and discoloration observed on sheathing.

Moisture Content: **Dry**
 Humidity - this area: **17%**
 Humidity - Outdoor: **10%**
 Area affected: **~2 Linear Ft**
 Suspected source(s) of water intrusion: **Previous lack of roof for 40 days**

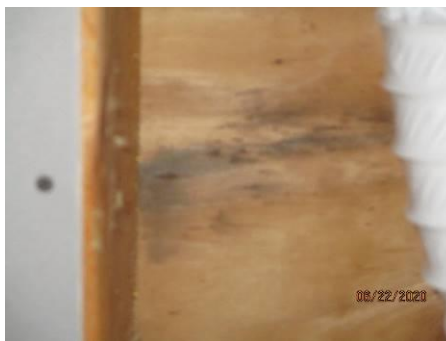
BATHROOM (SHEATHING) [Ceiling Corner]

Suspect mold-like growth was observed.

Mold-like growth observed on sheathing.

Moisture Content: **Dry**
 Humidity - this area: **17%**
 Humidity - Outdoor: **10%**
 Area affected: **~1 Linear Ft**
 Suspected source(s) of water intrusion: **Previous lack of roof for 40 days**

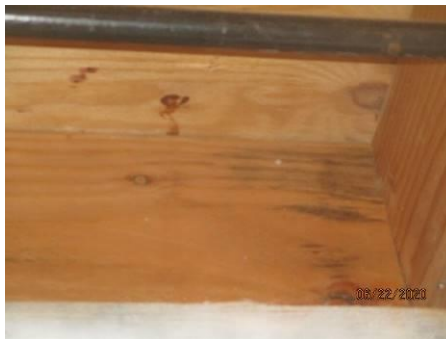
BATHROOM [East Side]

Staining, discoloration, and/or visible signs of water damage were observed.

Water staining and discoloration observed on sheathing.

Moisture Content: **Dry**
 Humidity - this area: **17%**
 Humidity - Outdoor: **10%**
 Area affected: **~2 Linear Ft**
 Suspected source(s) of water intrusion: **Previous lack of roof for 40 days**

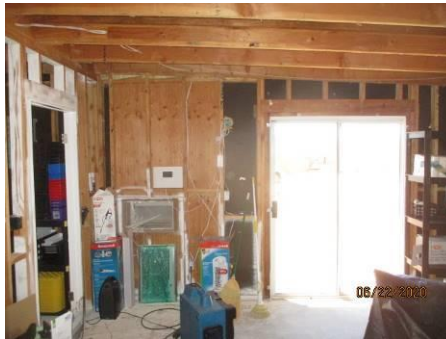
MASTER BEDROOM [South Side]

Staining, discoloration, and/or visible signs of water damage were observed.

Water staining and discoloration observed on sheathing and joists.

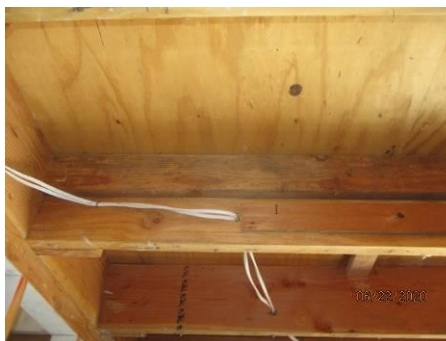
MASTER BEDROOM [South Side]

Staining, discoloration, and/or visible signs of water damage were observed.

Water staining and discoloration observed on sheathing and joists.

Area affected: **~12 Linear Ft**

Suspected source(s) of water intrusion: **Previous lack of roof for 40 days**

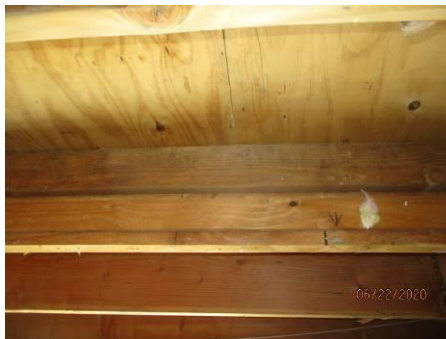
MASTER BEDROOM (JOIST) [South Side]

DE3	Master Bedroom (Joist)	Mold Growth: Ceratocystis / Ophiostoma group	Recommended by inspector and approved by client
DE4	Bedroom (Stud)	Mold Growth: Ceratocystis / Ophiostoma group	Recommended by inspector and approved by client

Suspect mold-like growth was observed.

Mold-like growth observed on joist.

Area affected: **~12 Linear Ft**

Suspected source(s) of water intrusion: **Previous lack of roof for 40 days**

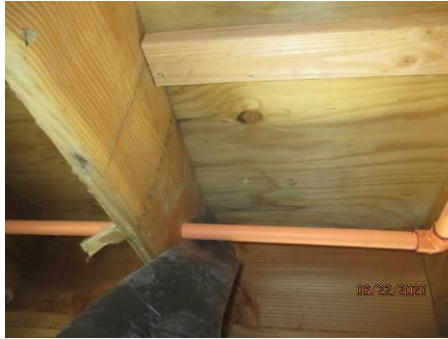
MASTER BEDROOM [Ceiling Corner]

Staining, discoloration, and/or visible signs of water damage were observed.

Water staining and discoloration observed on sheathing and joists.

Moisture Content: **Dry**
Humidity - this area: **17%**
Humidity - Outdoor: **10%**
Area affected: **~3 x 3 Ft**
Suspected source(s) of water intrusion: **Previous lack of roof for 40 days**

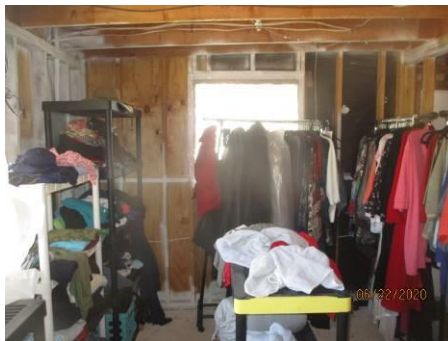
BEDROOM [West Side]

Client stated previous water intrusion affected this area.

Client stated previous roof leak occurred in area.

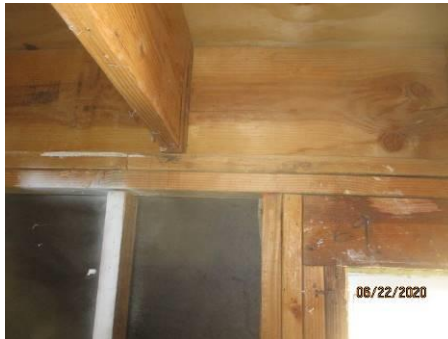
BEDROOM [West Side]

Staining, discoloration, and/or visible signs of water damage were observed.

Water staining and discoloration observed on studs.

Moisture Content: **Dry**
Humidity - this area: **17%**
Humidity - Outdoor: **10%**
Area affected: **~3 Linear Ft**
Suspected source(s) of water intrusion: **Previous lack of roof for 40 days**

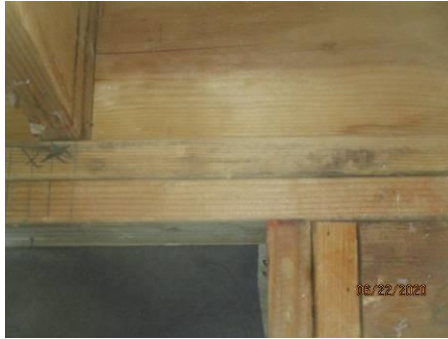
BEDROOM (STUD) [West Side]

Suspect mold-like growth was observed.

Mold-like growth observed on stud.

Area affected: **~2 Linear Ft**

Suspected source(s) of water intrusion: **Previous lack of roof for 40 days**

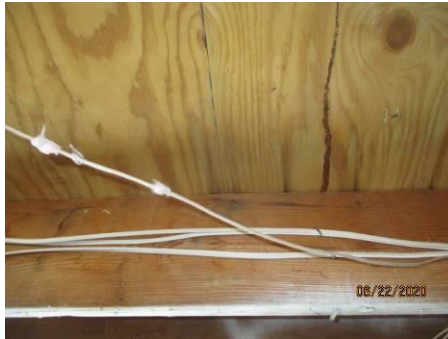
BEDROOM [West Side]

Staining, discoloration, and/or visible signs of water damage were observed.

Water staining and discoloration observed on studs and sheathing.

Area affected: **~3 x 3 Ft**

Suspected source(s) of water intrusion: **Previous lack of roof for 40 days**
