Desert Detection Home Inspection LLC

May 18th 2020, 10:00 am

BUILDING ADDRESS: 58137 Sun Mesa dr
CITY: Yucca
STATE: CA
ZIP CODE: 92284
INSPECTION DESCRIPTION: Mold Inspection
SQUARE FOOTAGE:

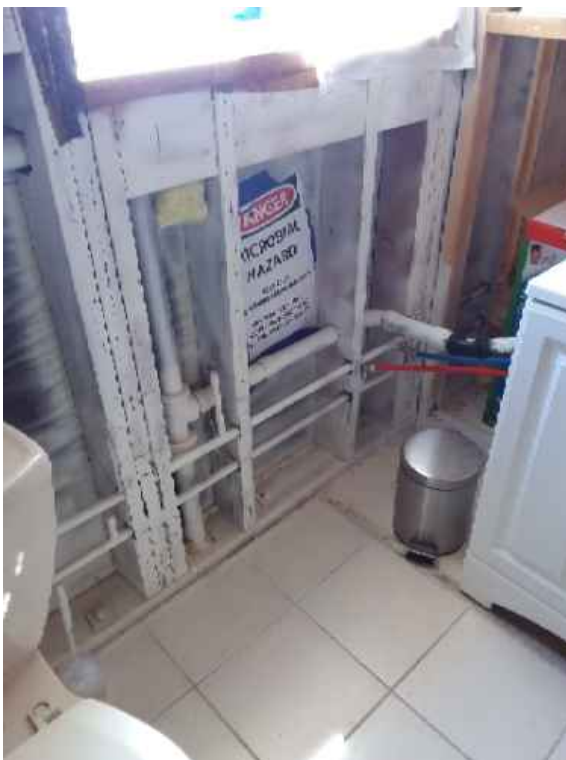
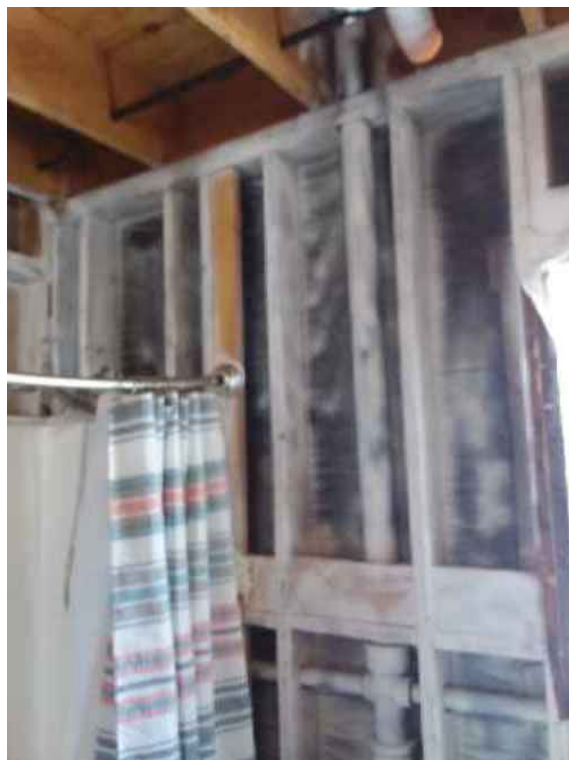
The bathroom has been taken down to the framing, the areas have been cleaned and painted with kiltz.

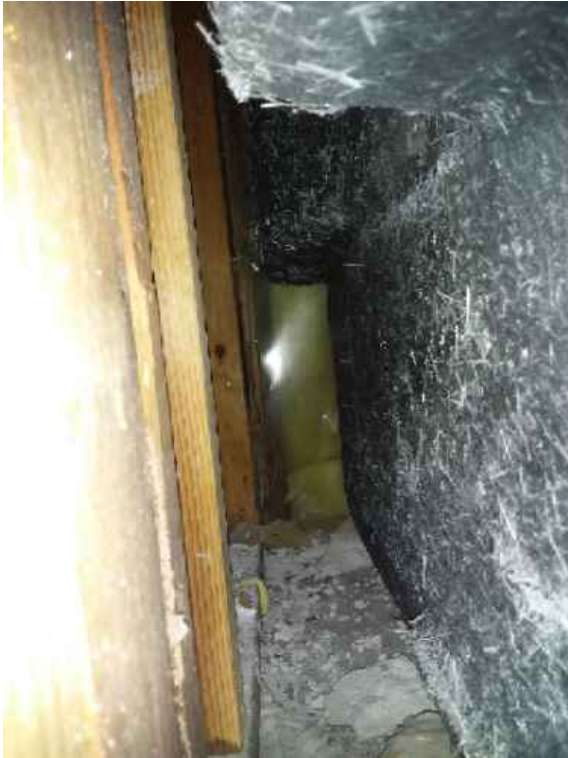
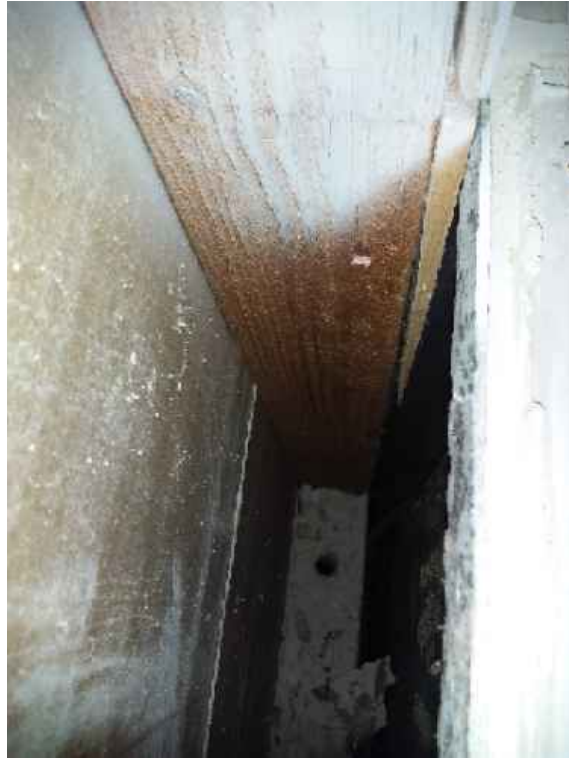
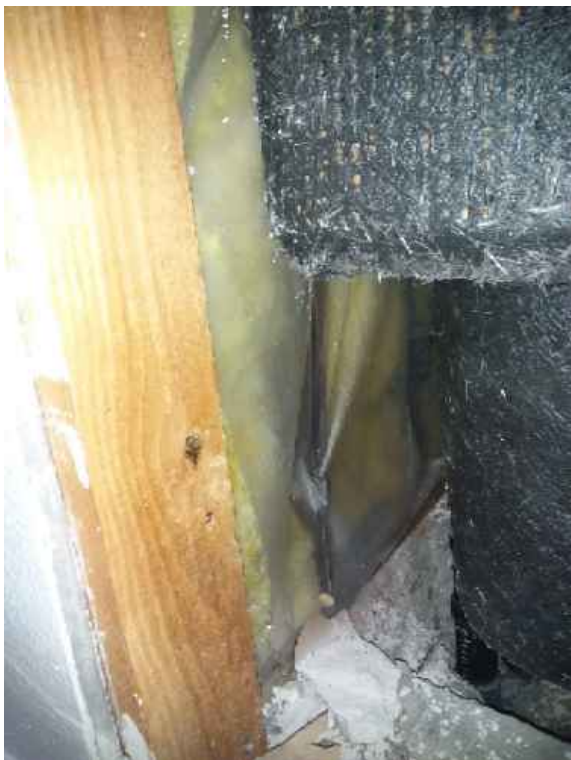
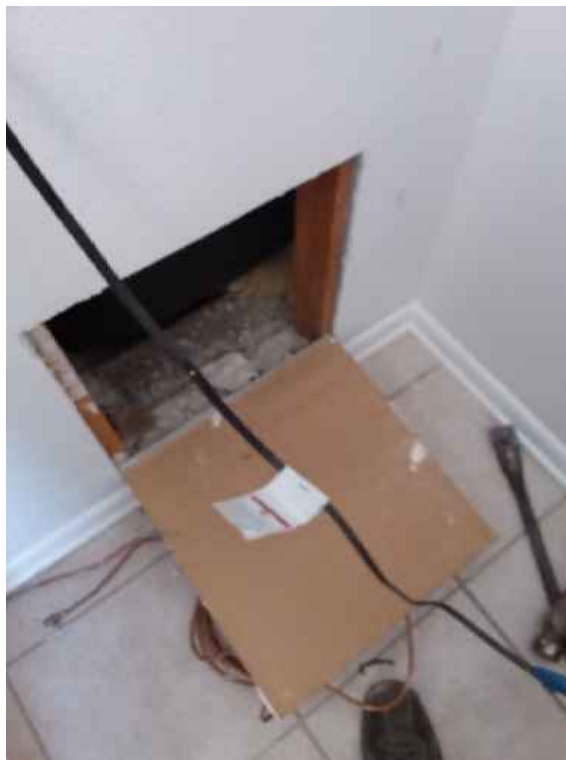
The area of concern was the structure behind the built in tub, the area above the tub structure was cleaned and painted. Behind the tub we observed and found no areas of suspected mold growth on the areas that could be seen. The tub is going to be removed and replaced with a new one. Recommend cleaning the area and spraying with concrobium mold control.

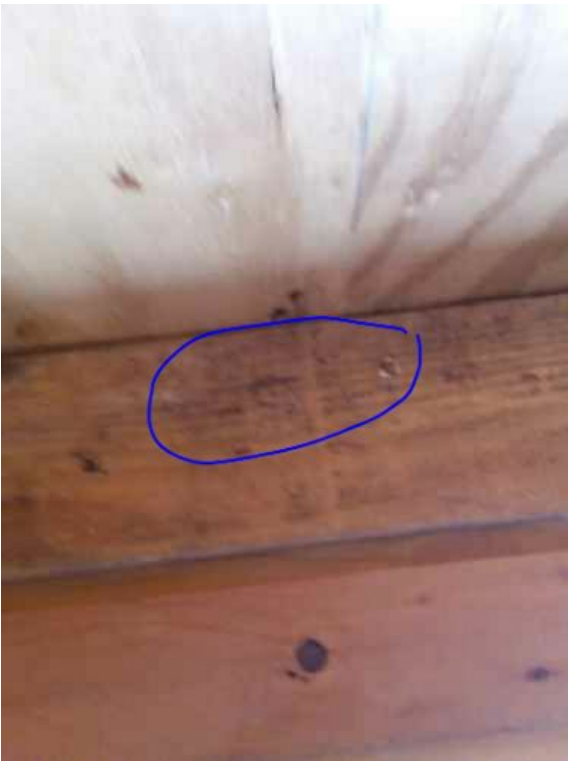
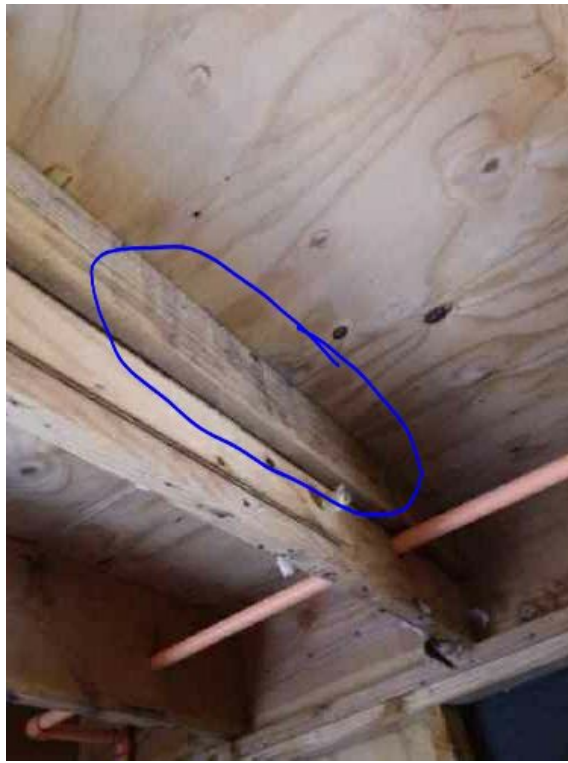
One of the rafters in the master bedroom had some darker areas that could have suspected mold growth, a strip sample was taken to confirm or deny.

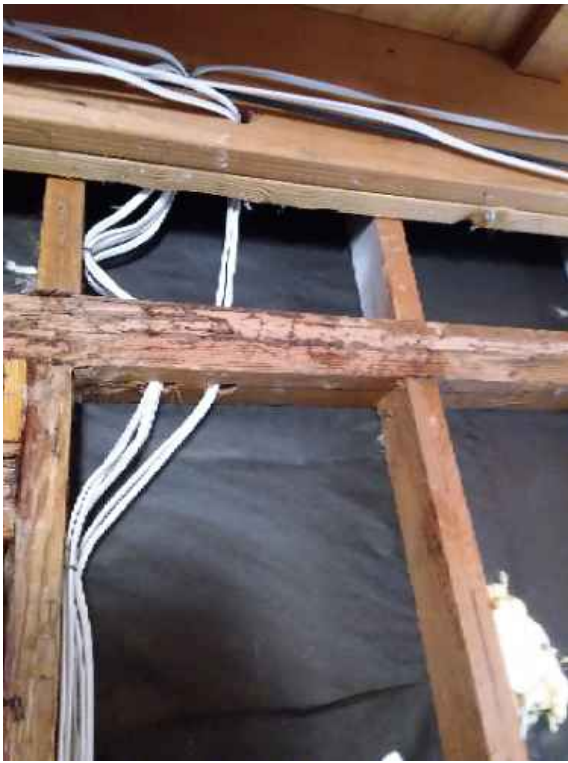
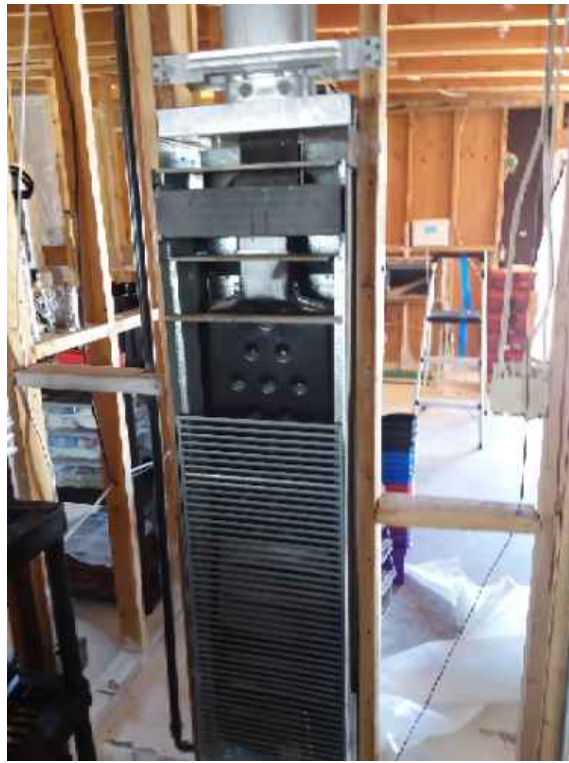
Some of the walls have termite damage, the heater has some dust particles recommend wiping down areas with water and vinegar.

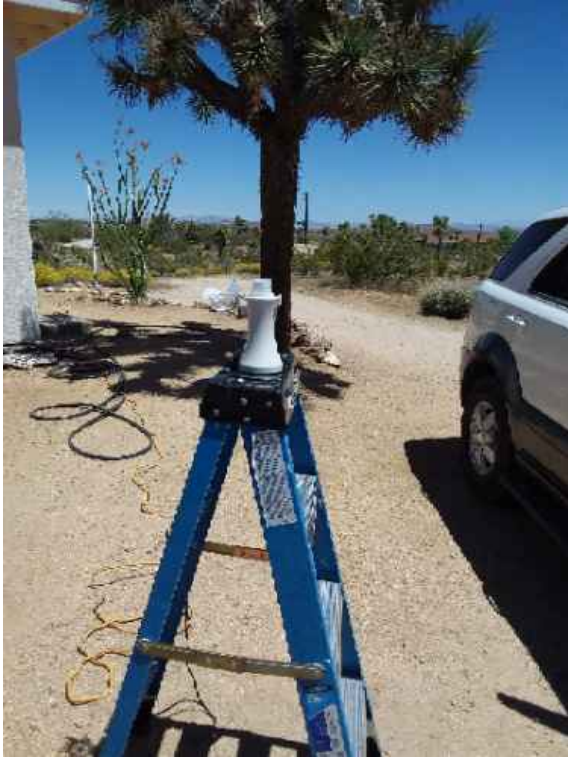
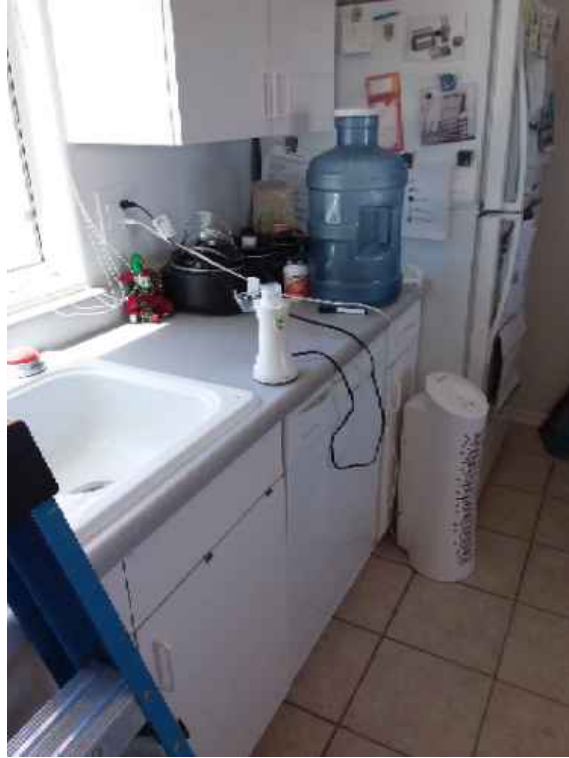
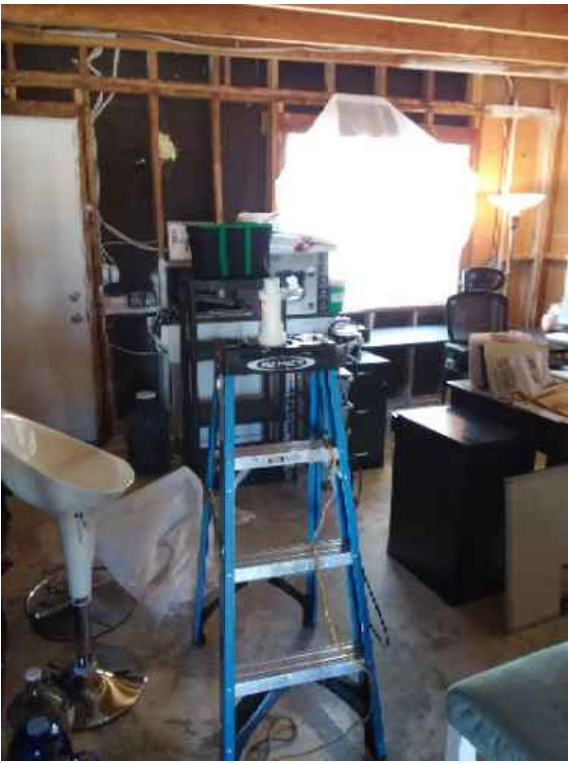
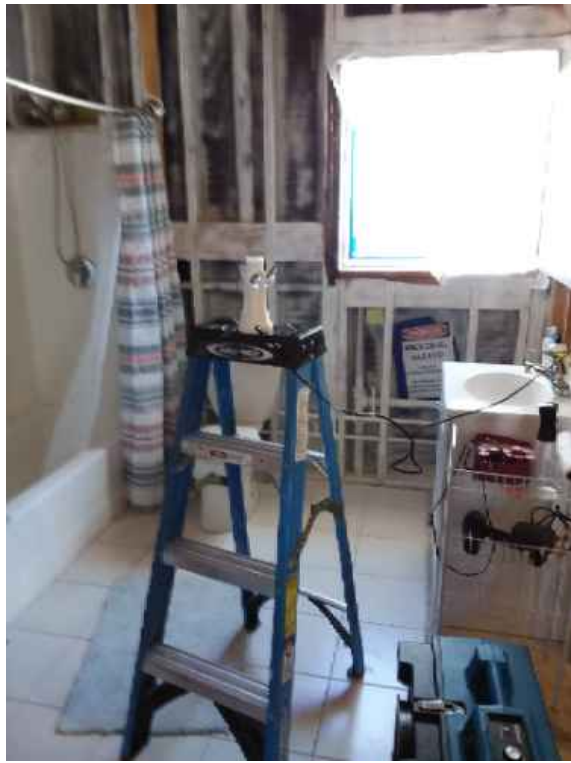
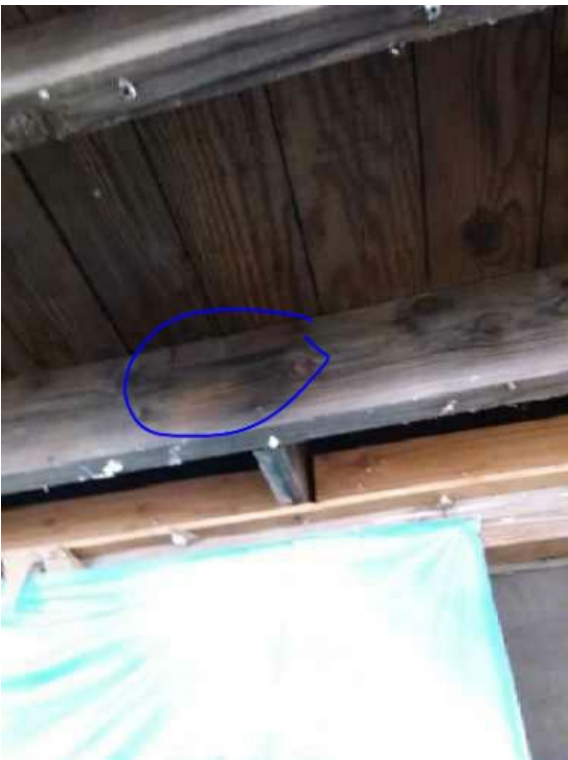
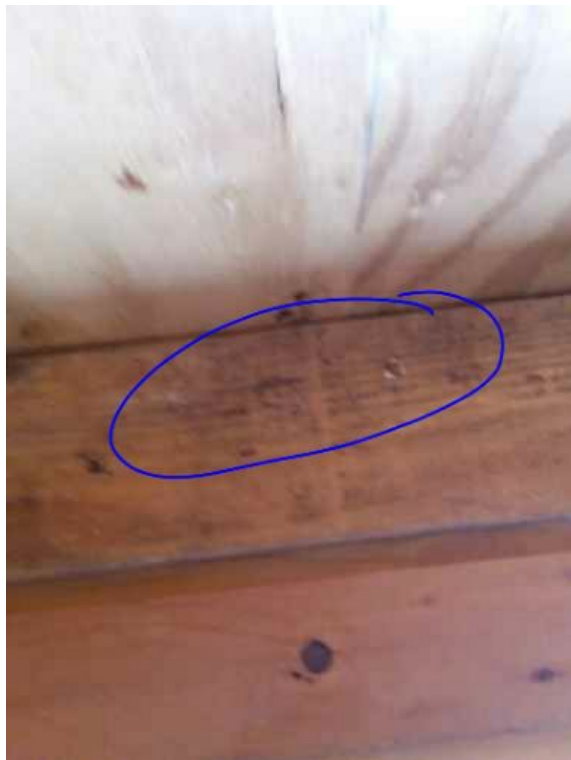
The areas of the house have been taken down to the studs and insulation has been removed. Areas were cleaned by a remediation company . Air tests and a strip test was done to confirm that area can be rebuilt. Tests will be available in 5 days. There was also a strip test done in the garage.
