Desert Detection Home Inspection LLC

May 18th 2020, 10:00 am

BUILDING ADDRESS: 58137 Sun Mesa dr
CITY: Yucca
STATE: CA
ZIP CODE: 92284
INSPECTION DESCRIPTION: Mold Inspection
SQUARE FOOTAGE:

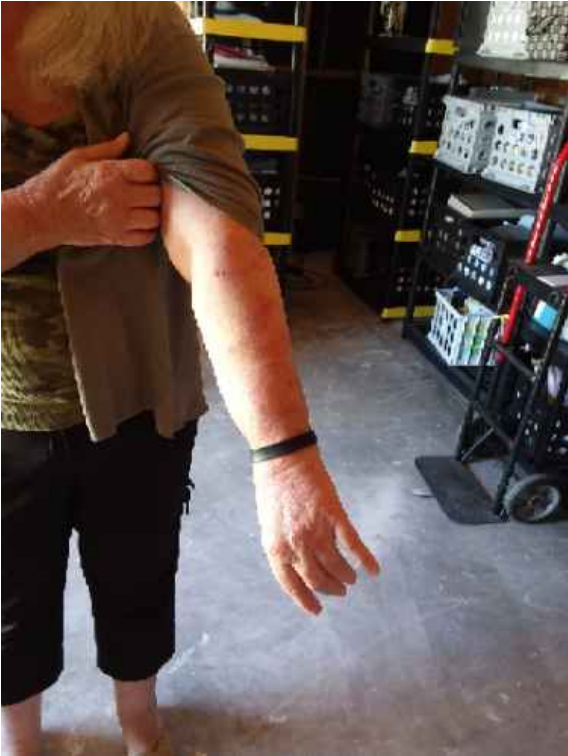
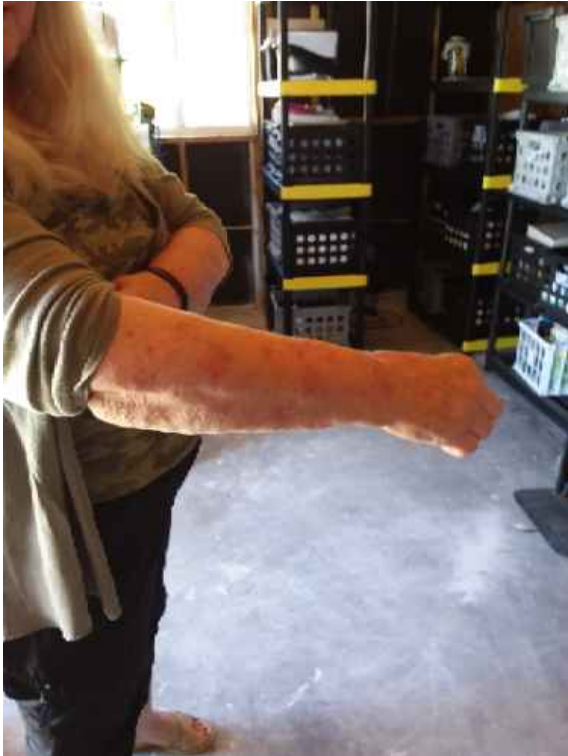
Linda's body had issues with her health it is hopeful that the ability to have the tests come back normal and the house can be rebuilt will help.
